Manhole Inspection Summary

Manhole # S23KK_028MH

Insp Date: **7/5/05 7:29 PM**

Location Address: **2400 FRANCIS ST**

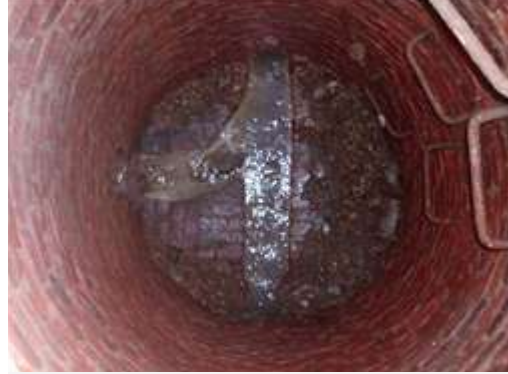
Top View

Corroded steps. Bench and Channel debris.

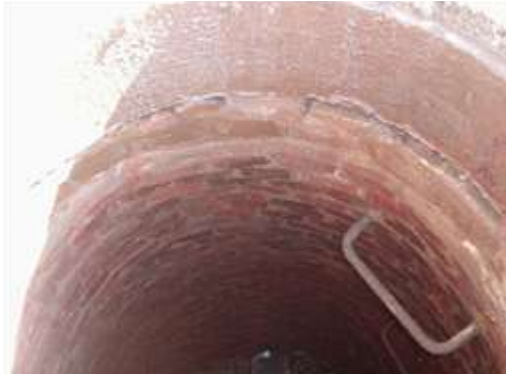
Defect

Frame leaks. Frame leaks. Adjustment deterioration and infiltration. Barrel infiltration.

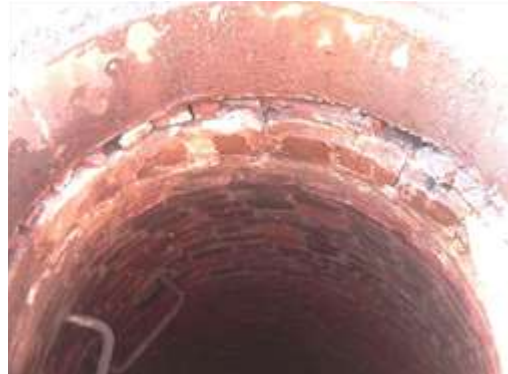
Defect

Frame leaks. Frame leaks. Adjustment deterioration, loose brick and infiltration. Barrel infiltration.

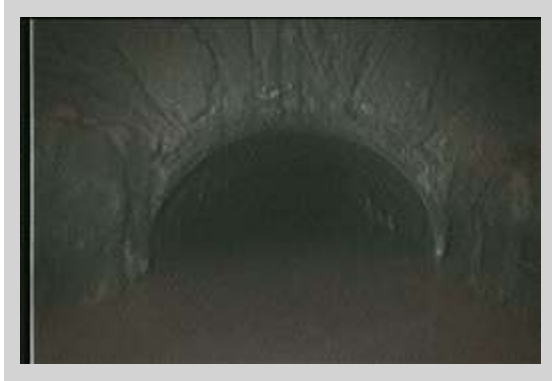
Pipe Out @ 12 O'Clock

Deposits: ☐ None ☐ Mud ☐ Sludge ☐ Debris ☒ Grease

Silt Depth: **0** (in.) Deposits Extent: **Light**

Infiltration: **Evidence** Pipe Seal Cond: **Cracked**

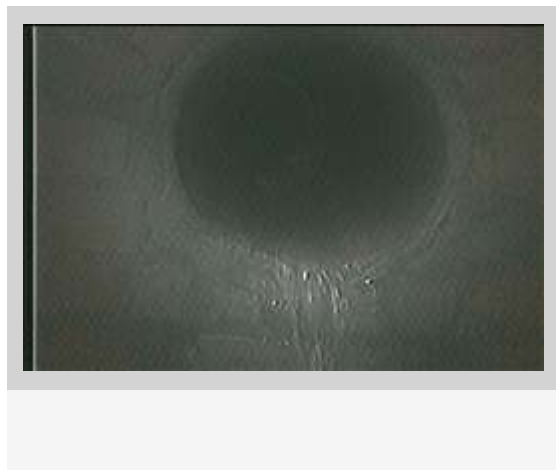
Pipe In @ 9 O'Clock

Infiltration: **Evidence**

Pipe Seal Cond: **Cracked**

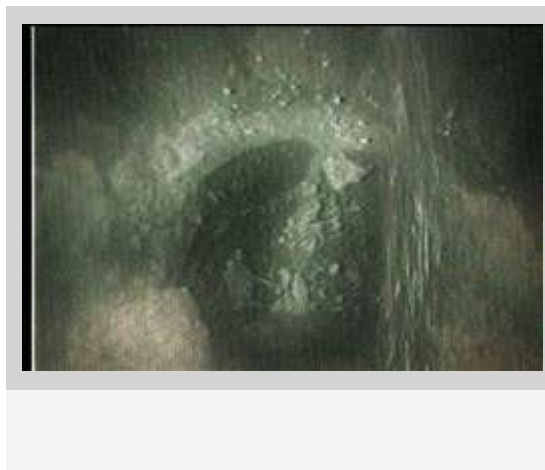
Drop In @ 9 O'Clock

Drop Condition: **Partly Clogged**
